REPORT TO THE HISTORIC PRESERVATION COMMISSION

SUBJECT: CONSIDERATION OF APPROVAL OF REQUEST BY THE PROPERTY OWNER
TO RESCIND THE DESIGNATION OF THE JUDGE WILLIAM D. CRICHTON HOME
(HR#005, 1906) LOCATED AT 1718 L STREET AS A HERITAGE PROPERTY AND
ADOPTION OF FINDINGS NECESSARY TO SUPPORT RESCINDING THE
DESIGNATION, PURSUANT TO FMC 12-1612

Request to De-list the Judge Crichton Home as a Heritage Property, June 28, 2010

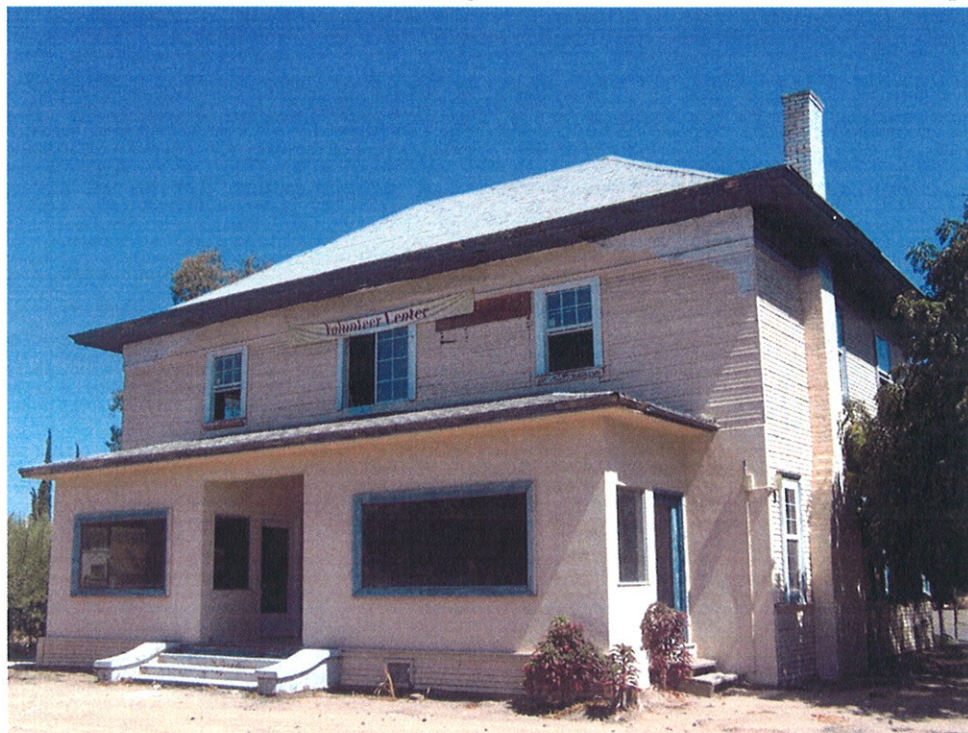
P5b Photo date: 8.25.05

***P3a. Description:** This full two-story rectangular plan home faces "west" onto L Street and is an example of the early vernacular interpretation of the Prairie. It has sustained numerous alterations over time, but original features include the medium pitched hip roof with bellcast flare, wide overhanging eaves and a plain boxed cornice. The façade is symmetrical with three windows on the second story over what is now a fully enclosed one story hipped roof porch and entry way. The home is standard frame construction and is clad in horizontal lapped siding with a stucco veneer on the first story façade. The solid wood front door is centrally located and has sidelights that have been replaced. A brick fireplace is on the "south" elevation. Most original double hung sash windows have been replaced with new inserts that include faux muntins. However a nice series of double hung ribbon windows remain on the first floor and wrap the southeast corner, providing light for what was possibly a sunroom or sitting room. A bay window on the north elevation has been unfortunately in-filled. An early 2-story addition to the rear of the home apparently accommodated a bathroom on the first floor and a sleeping porch on the second. A parking lot is directly behind the home. Off the northeast corner is a one-story wood frame garage with gable roof, exposed rafter tails and lapped wood siding.

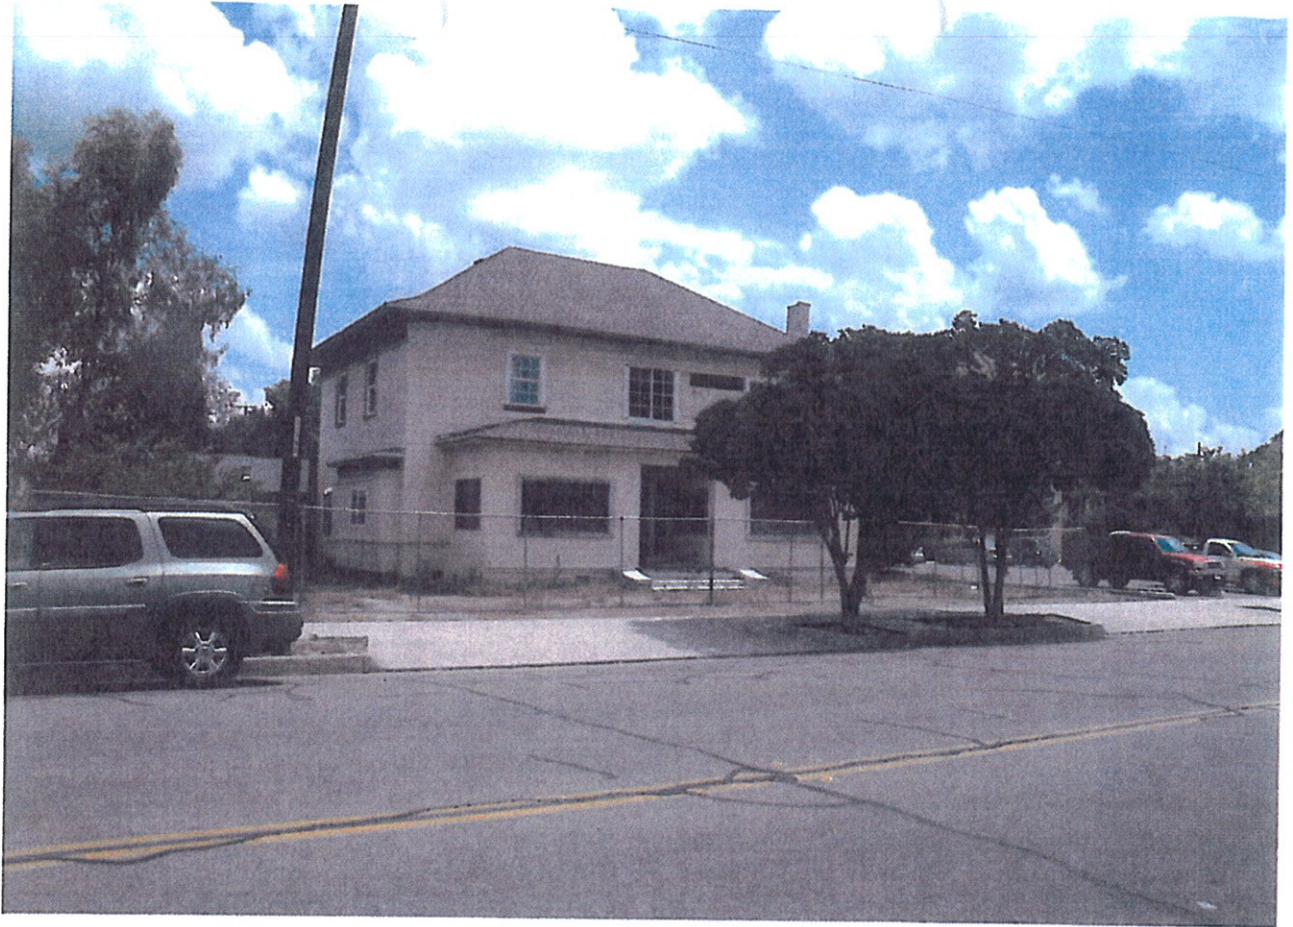
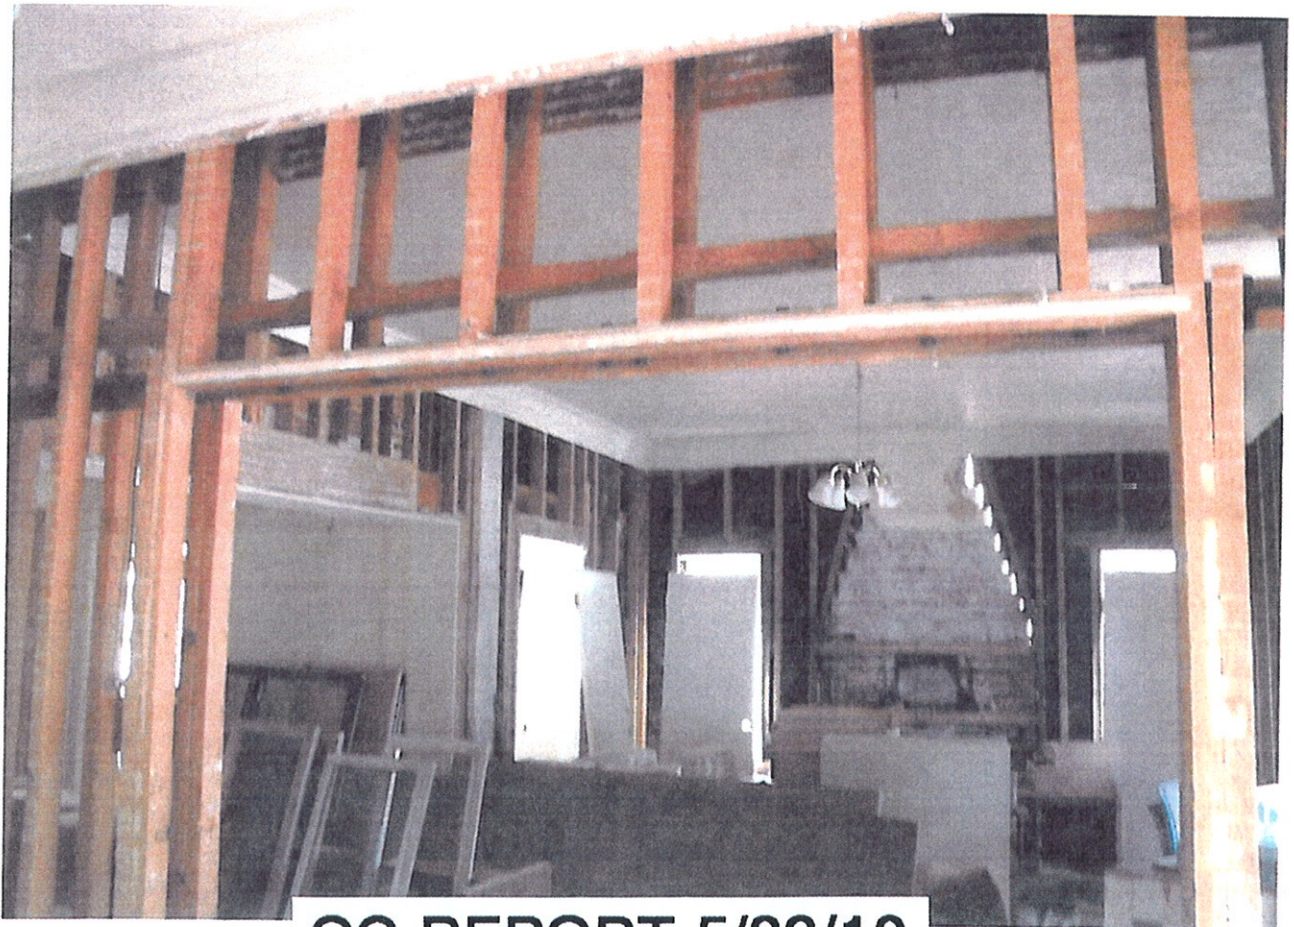
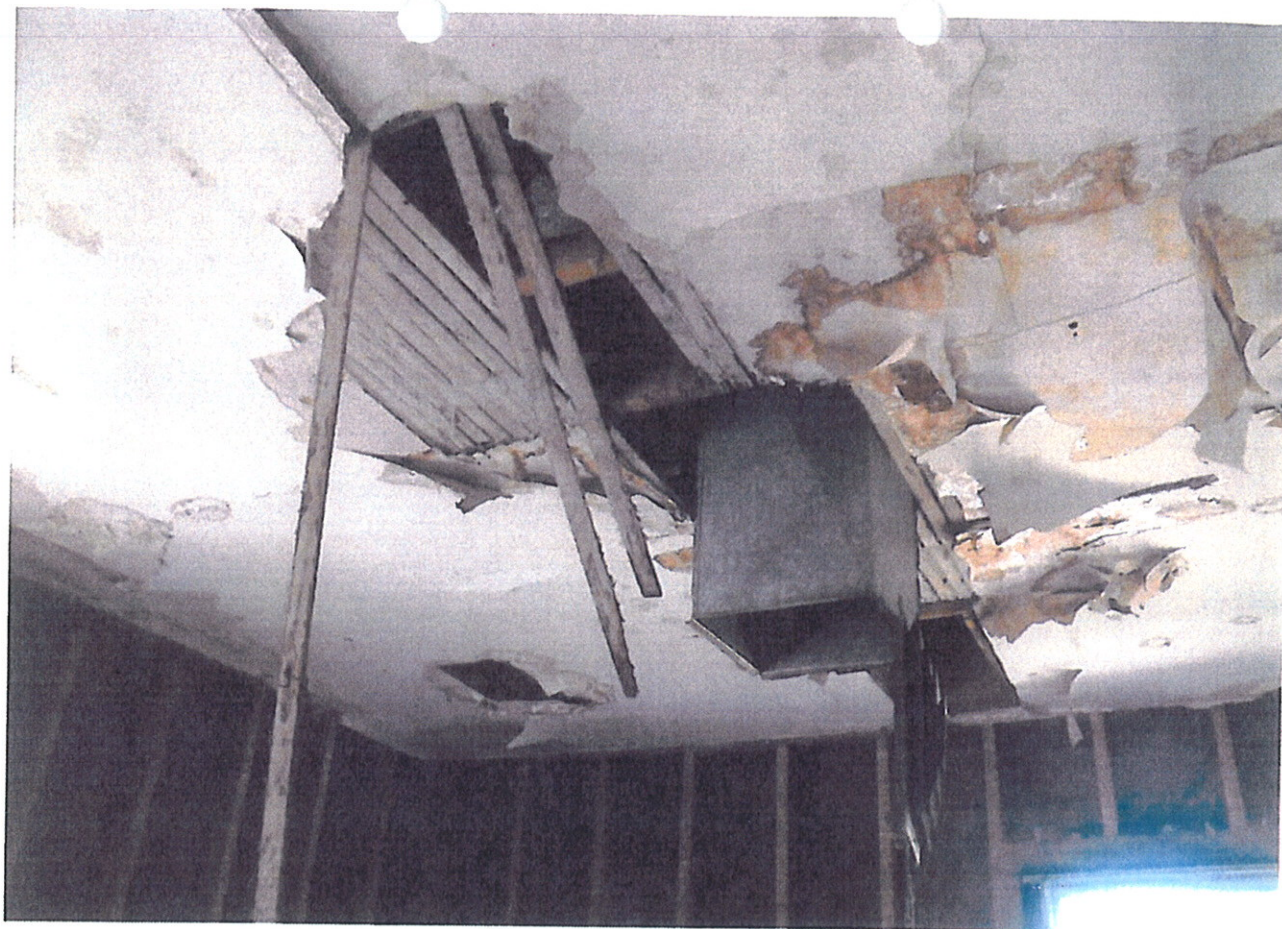
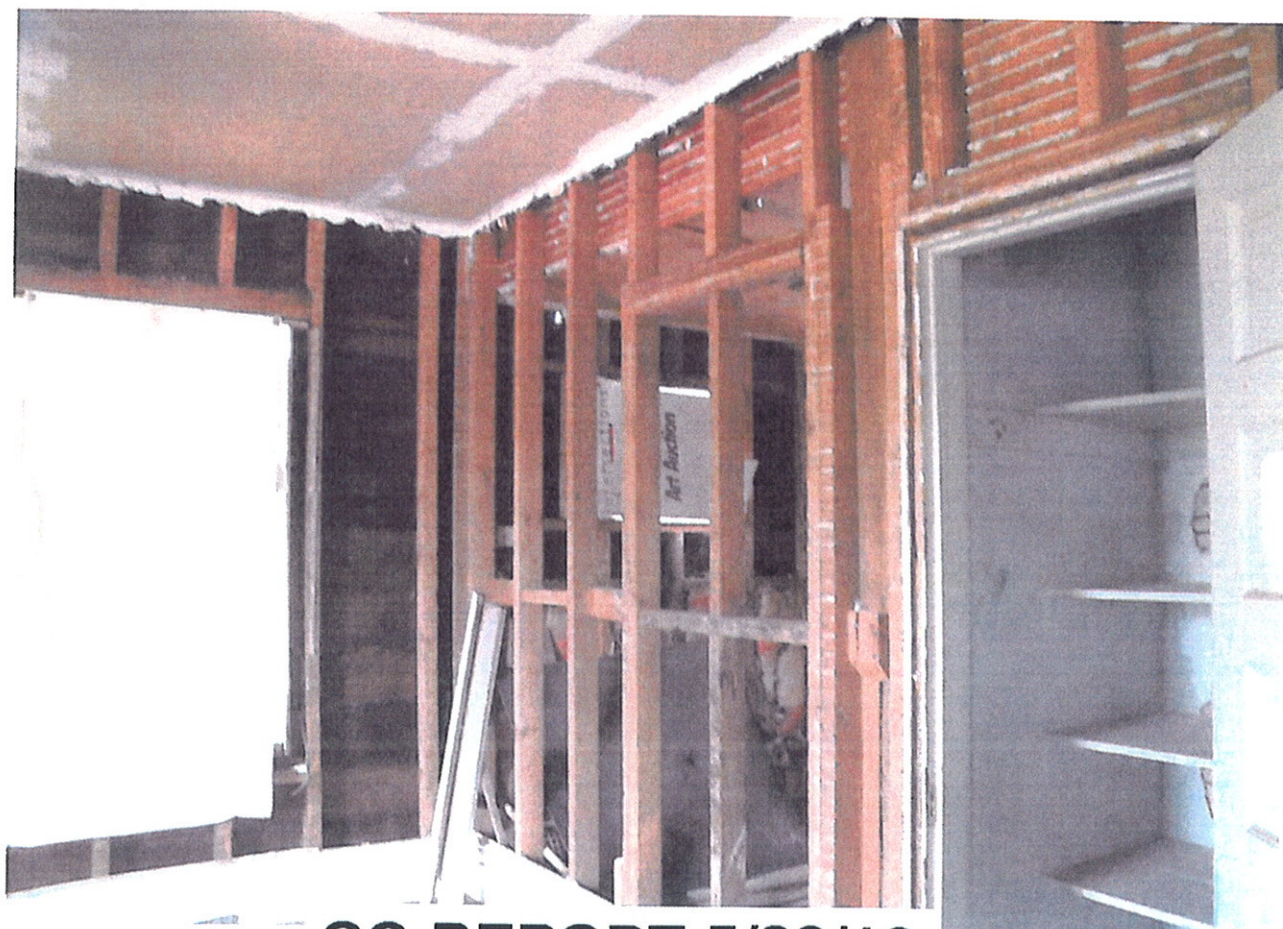
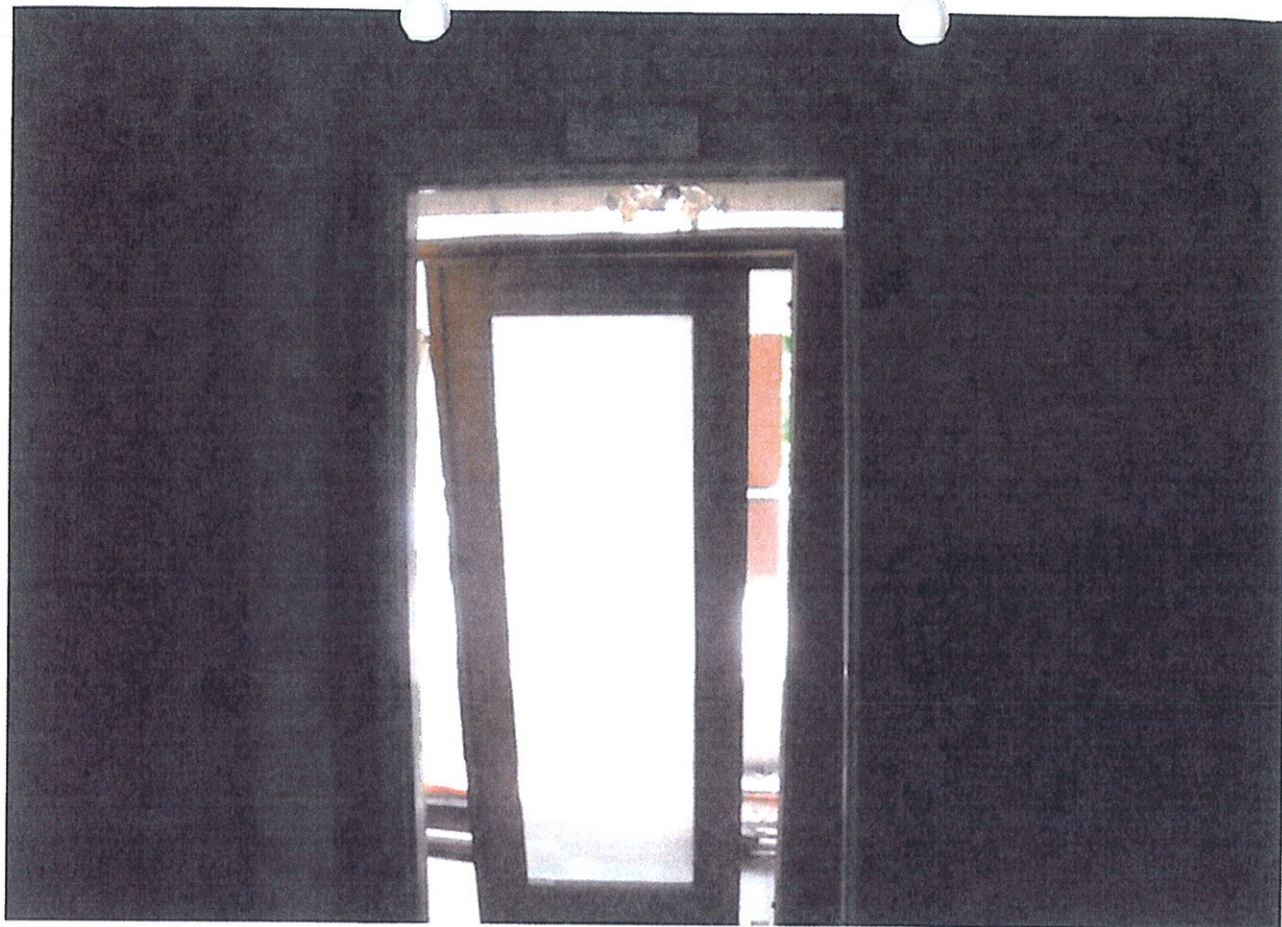
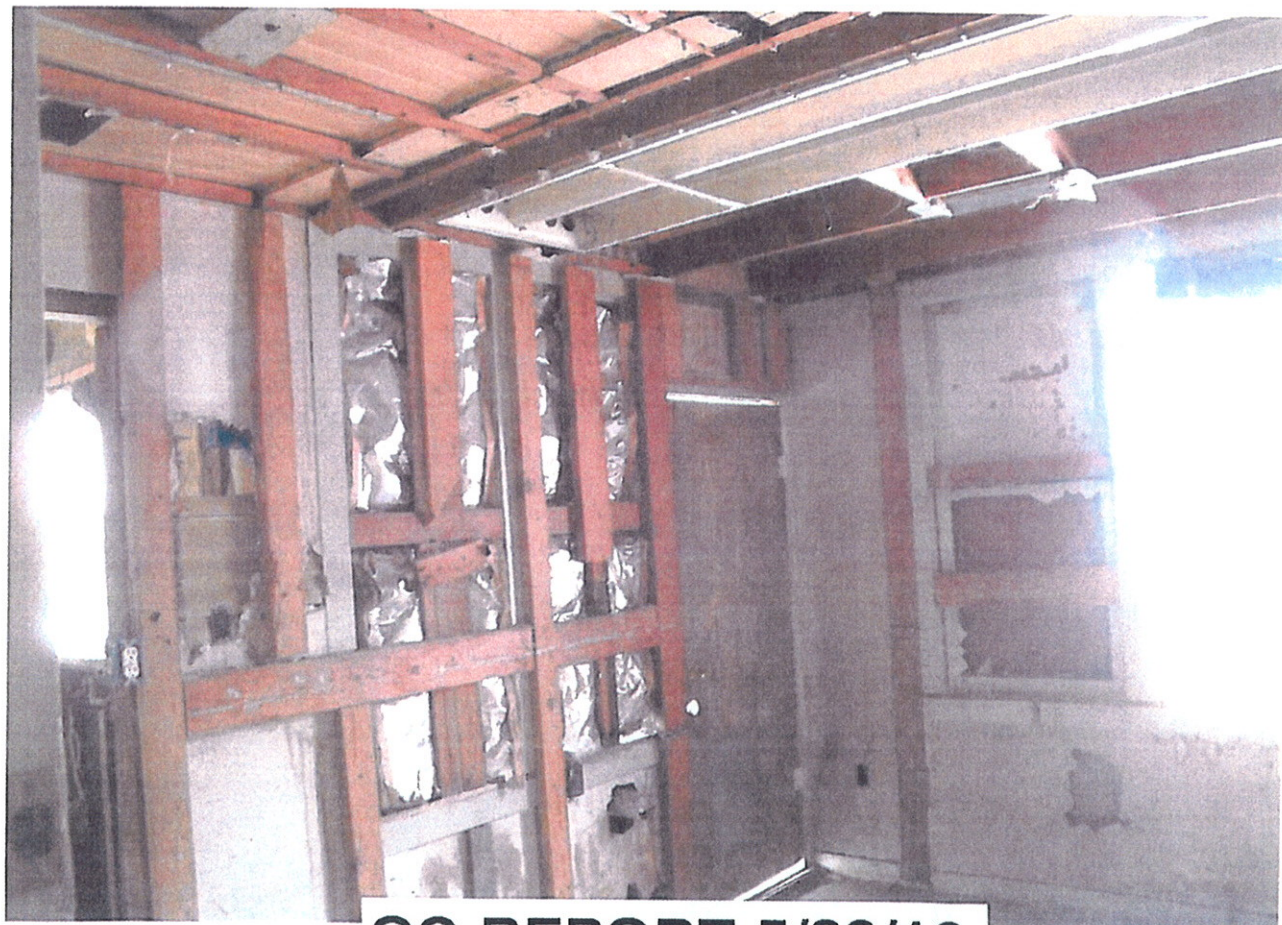
GC REPORT 5/26/10

The inspection of this property revealed a former residential home that over time has been partially renovated and is currently 90% gutted with various portions of the building being used for storage. The home is infested with animals (cats) that have used the structure for a litter box for many years. The inside is further being subjected to damage from the elements due to broken windows and partial wall repairs. The front lower portion of the structure was altered in the past to add interior space and does not match the original exterior of the building in appearance or materials.

The exterior of the building is in poor condition with respect to appearance and paint condition and shows considerable areas that would need immediate attention to stop deterioration. The roof looks to be in good shape. The windows and siding are a total patchwork of mismatched materials and types along with partial repairs in many areas. The masonry chimney is in disrepair and needs attention. The majority or the remainder of the property is poorly maintained with little or no landscaping and debris strewn paved areas.

The basement has interior access and is mostly for simple under structure access and water heater location. The foundation is brick and much of the support posts are in contact with soil with wood retaining areas.

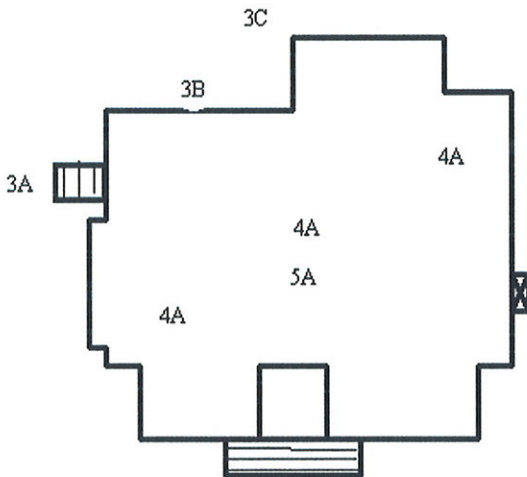
Fungus infection and damage noted to the steps as indicated on the diagram. Condition appears to be due to exposure to the elements.

Fungus infection, earth to wood contact and damage noted to the basement door and steps.

Fungus infection and damage noted to the rear door over hang as indicated on the diagram. Condition appears to be due to exposure to the elements.

Water damage noted to the ceilings as indicated on the diagram. This condition appears to be due to past roof leaks.

Earth-wood contact noted at the retaining walls and pier posts in the sub area as indicated on the diagram. This condition is conducive to subterranean termites infestations, excessive moisture conditions and fungus development.

We recommend other trades to make necessary repairs and corrections.
